#### **SECTION IV – FACILITY DESIGN (STORAGE)**

## A. STORAGE AREAS FOR DRUMS / CONTAINERS / TANKS / OTHER DEVICES

**Secondary Containment Certification**

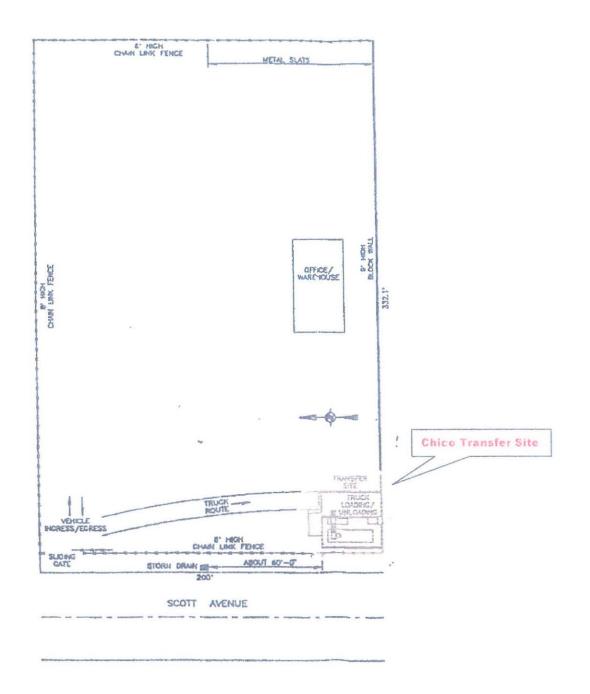
It was noted in Figure IV-A-2, Transfer Area Site Plan, that the truck containment slab will be extended an additional 40 feet as part of a future project. It was also noted that the existing truck containment slab has some cracking which needs to be repaired.

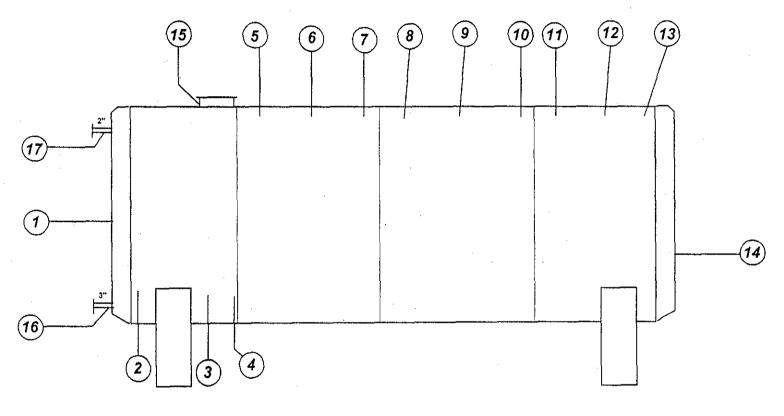
95'-5"O.D. 27' 4" L

The tank paint was found in good condition with no peeling or damage. There was indication of previous general corrosion/pitting with an average of 10-20 mils and a high of 80 mils. The area next to the 80 mil pit was UT'd at .240". Other than some areas with previous corrosion/pitting to 30 mils, the horizontal and circumferential welds seams were all found in fair condition with no obvious defects or indications of leakage. The coating on the east and west heads were also in good condition. The east head had random areas of previous corrosion/pitting, with an average of 10-20 and a max of 70 mils. This head was UT'd at 24"-25". The west head had previous corrosion/pitting, with an average of 10-20 and a max of 50 mils. This head was UT'd at 23"-24". No banding or peaking was found. No indication of out-of-round noted. The nozzles and couplings appeared in good condition with the paint intact and no corrosion or pitting. The manway appeared in good condition with no corrosion or pitting found and the paint was intact. There are no davits on the shell. There was no ground wire found. The anchor bolts, which were embedded into the concrete pedestals, were all hammer tested and found to be sound. The two hold down straps were found in secured with no corrosion or damage. The concrete pedestals were found in good condition with no spalling or cracks. No nameplate was found. Review of the UT readings revealed no significant corrosion.

1) T - 240" 2) T - 24	0" 3) T - 250"	4) T - 240"	5) T240"	6) T250"	7) T - 240"	8) T240"	9) T240"
N - 245" N - 24	5" N - 250"	N - 245"	N240"	N245"	N - 240"	N235"	N245"
B - 240" B - 24	0" B - 245"	B - 240"	B240	B240"	B - 240"	B240"	B240"
S - 250" S - 24	5" S - 250"	S - 250"	S240"	S245"	S - 245"	S235"	S245"

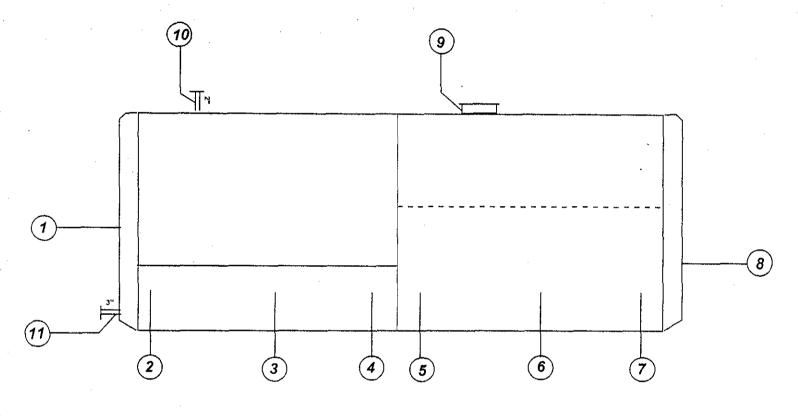
# TANK # T-2 WASTE ANTIFREEZE / WASTE GLYCOL CARBON STEEL

The tank paint was found to be in good condition with no peeling or damage. The horizontal and circumferential welds seams were all found in good condition with no obvious defects or indications of leakage. The coating on the east and west heads were found in the same condition as the shell. No banding or peaking was found. No indication of out-of-round noted. The nozzles and couplings appeared in good condition with the paint intact and no corrosion or pitting. The manway appeared in good condition with no corrosion or pitting found and the paint was intact. There are no davits on the shell. There was no ground wire found. The anchor bolts, which were embedded into the concrete pedestals, were all hammer tested and found to be sound. The two hold down straps were found in secured with no corrosion or damage. The concrete pedestals were found in good condition with no spalling or cracks. No nameplate was found. Review of the UT readings revealed no significant corrosion.

1) T125" 2) T130" 3) N125" N130" B125" B125" S125" C125"	T - 130" 4) T - 130" N - 130" N - 130" B - 125" B - 125" S - 125" S - 125"	5) T125" N125" B125" S130"	6) T130" N130" B125" S130"	7) T130" N130" B125" S125"	8) T130" N130" B130" S130" C130"	9) N240" E240" S240" W240"
--	---	-------------------------------------	-------------------------------------	-------------------------------------	--	-------------------------------------
